GUARDING THE HEALTH AND AVAILABILITY OF A BRUSHLESS GENERATOR

USING AN EARTH FAULT RESISTANCE MONITOR

John Demcko, Senior Consulting Engineer, Arizona Public Service Company
John Reschovsky, President, Accumetrics Associates, Inc.

Presented at ELECTRIC POWER 2007 Conference, May 1-3, 2007, Chicago, IL (USA).

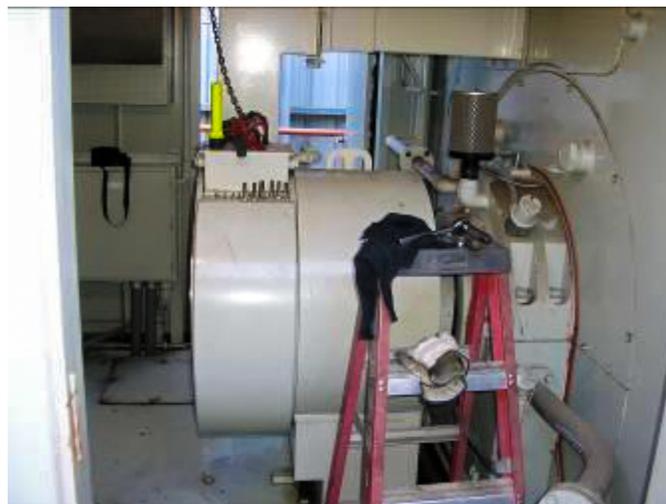
Figure 2
Brushless Exciter Overview

Installation consists of mounting both stationary and rotating EFREM components, making connections to the generator field and interfacing EFREM outputs to external device(s). **Figure 2** is a photo of the unit's brushless exciter supplied to the generator manufacturer by a domestic company.

The alternator and diode wheel are contained within the housing with the diode wheel mounted closest to the end of the shaft. A circular steel end plate protects plant staff from direct contact with the rotating diode wheel. The standard EFREM transmitter package resembles a top hat or

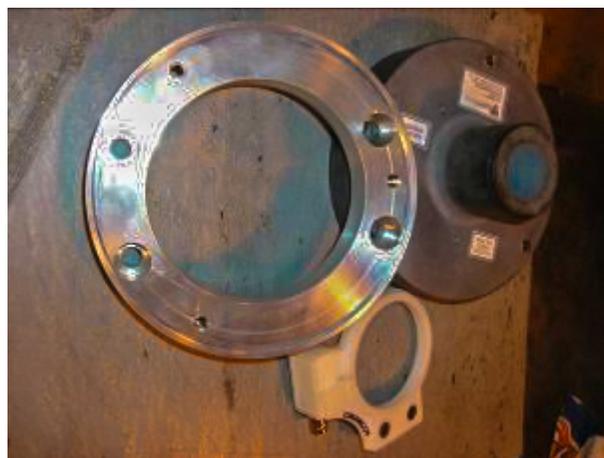
Figure 4
Adapter Plate, EFREM Transmitter “Top Hat” & Stationary Pickup

Figure 4 is a photo of the adaptor plate (top left), EFREM transmitter “top hat” (top right) and stationary pickup. The EFREM transmitter was then easily fitted to the shaft end. A bracket to hold the stationary receiver pickup over the transmitter was also fabricated and mounted across the diode wheel inspection hatch.

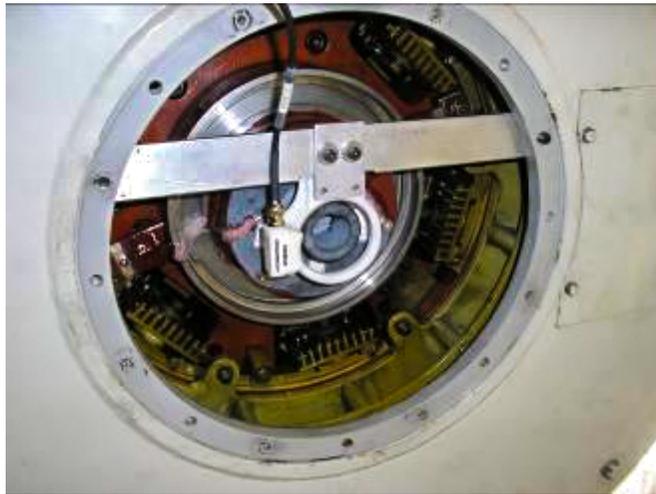
Figure 5
Mounted Adaptor Plate, Transmitter & Receiver Pickup Loop

Figure 5 documents the installed transmitter and stationary receiver pickup. Note that the existing diode wheel inspection hatch could not be reinstalled without modification. The reasons for this are twofold. First, the shaft length has been increased by the EFREM transmitter and adaptor plate. This lengthening, along with shaft expansion might cause a rub with the inspection hatch. Second, if the steel inspection hatch is mounted too closely to the stationary pickup, it might cause the system to detune.

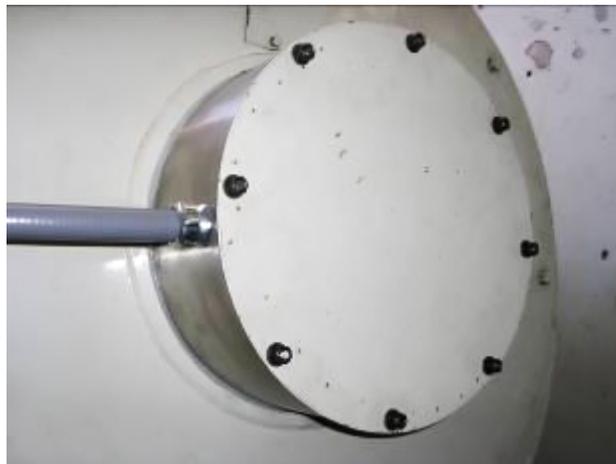
Figure 6
Diode Wheel Inspection Hatch Extension For Additional Clearance

A simple extension to the cover plate was fabricated to allow approximately six inches of clearance between the induction loop and the ferrous cover plate. **Figure 6** is a photo of the completed cover plate extension.

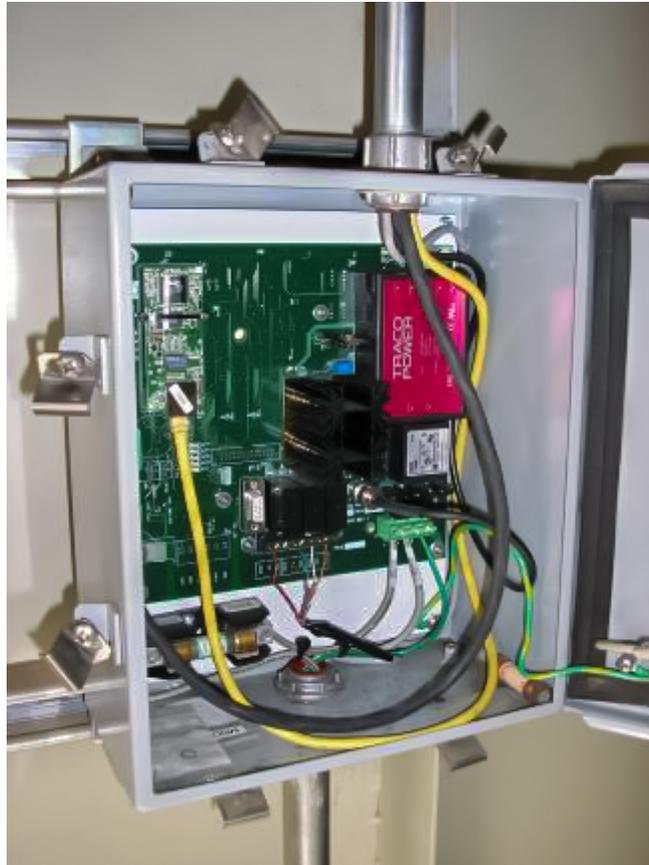
Figure 7
EFREM Receiver Mounted on Exciter Cubicle Wall

Last, **Figure 7** documents the installation of the EFREM Receiver and Power Supply unit. It was mounted on the wall of the exciter housing within a few feet of the EFREM transmitter. The cabling run to connect the receiver to the pickup coil was made through flexible conduit and is approximately 25 feet long. External connections to the receiver include ac power, pickup coil, alarm contacts and local network to a logging computer in the plant control room. Upon unit startup, no rebalancing of the unit was required after installation, and there was no measurable increase in diode wheel end bearing vibration. The skill set required to fabricate parts and mount the EFREM was well within the capabilities of the plant's electrical and mechanical personnel, and the time required to do the installation was not excessive.
